CALSPAN ON-SITE AIR BAG DEPLOYMENT INVESTIGATION

CALSPAN CASE NO. 95-20

**VEHICLE #1 - 1994 CHEVROLET CAMARO Z28 CONVERTIBLE
(DUAL AIR BAG-EQUIPPED)
LOCATION - UTAH
CRASH DATE - [REDACTED] 1995**

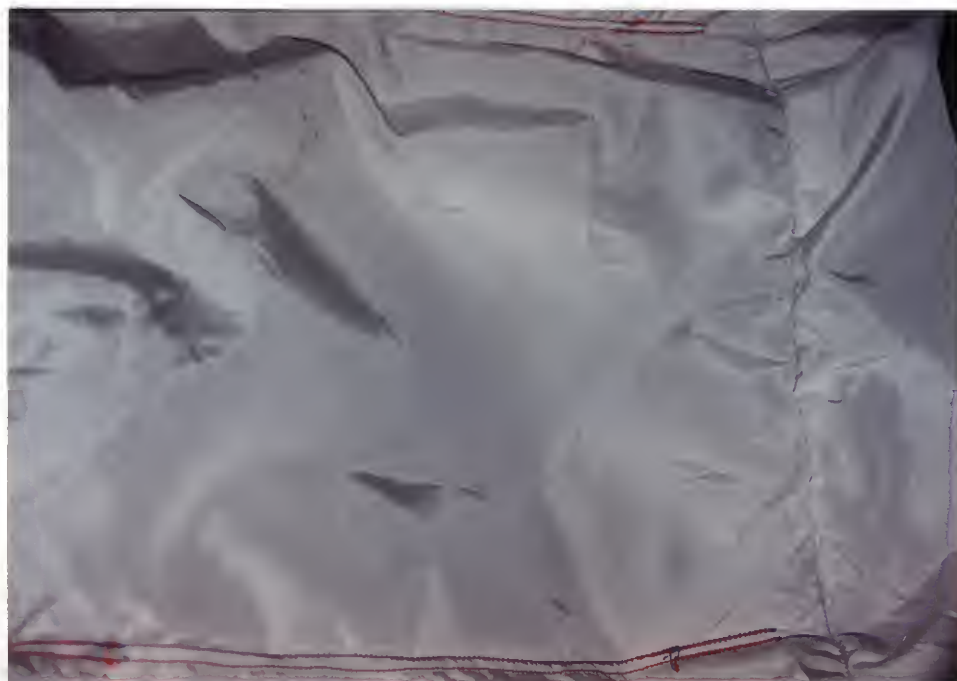
As the air bag deployed, the double stitching of the upper tether contacted the left side of his head and face (refer to photograph #102-#103 on pages A-53, A-54) resulting in a distinctive parallel contusion pattern. As the air bag continued to unfurl, the fabric of the air bag raked across the left side of the face. This was apparent from the extensive confluent abrasion pattern noted in the medical examiner's report.

91. Closer view of the passenger side air bag showing the upper and lower tether attachment points which can be seen by the two double lateral red stitch rows. These rows measured 33.66 cm (13.25") in length and were 30.5 cm (12.0") apart.

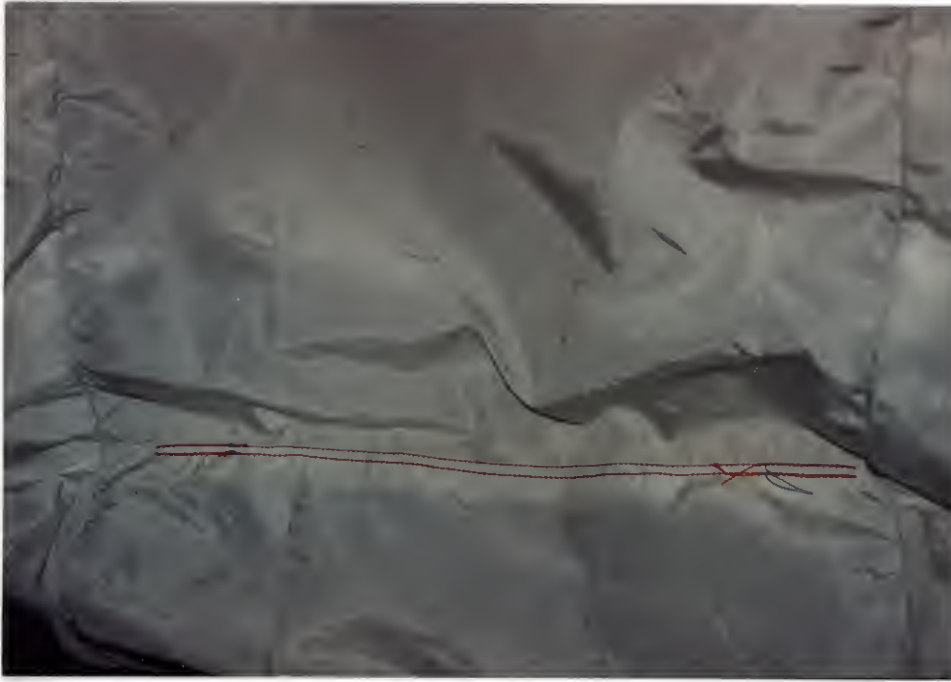
His head was rotated clockwise and upward by the air bag. This was determined from the abrasion of the left side of the neck and the extension neck injury. The air bag rolled the Pinna (auricle) of the left ear forward resulting in an extensive abrasion to the posterior surface (refer to photographs #104-#105 on pages A-55, A-56). A large tissue transfer observed on the air bag surface located between the upper and lower tether stitch rows was confirmed by the state crime laboratory to be skin.

92. Close-up view of the passenger side air bag showing body tissue transfer from the right front occupant which encompassed an area of 26.7 cm (10.5") in length and 2.5 cm (1.0") in width.

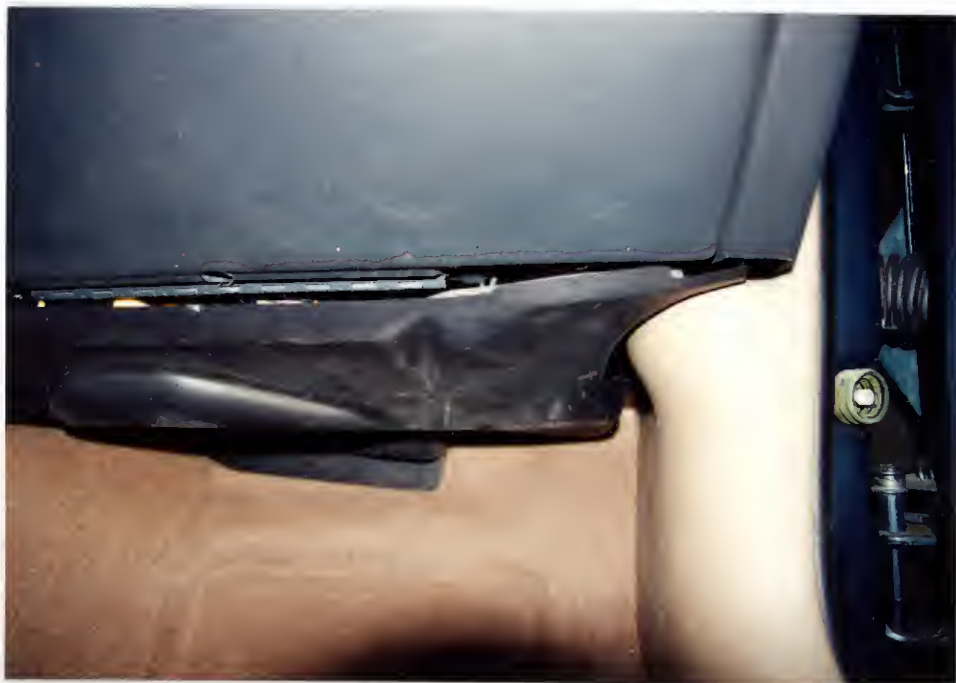
96. Closer view of the right side of the hush panel showing a cloth transfer mark.

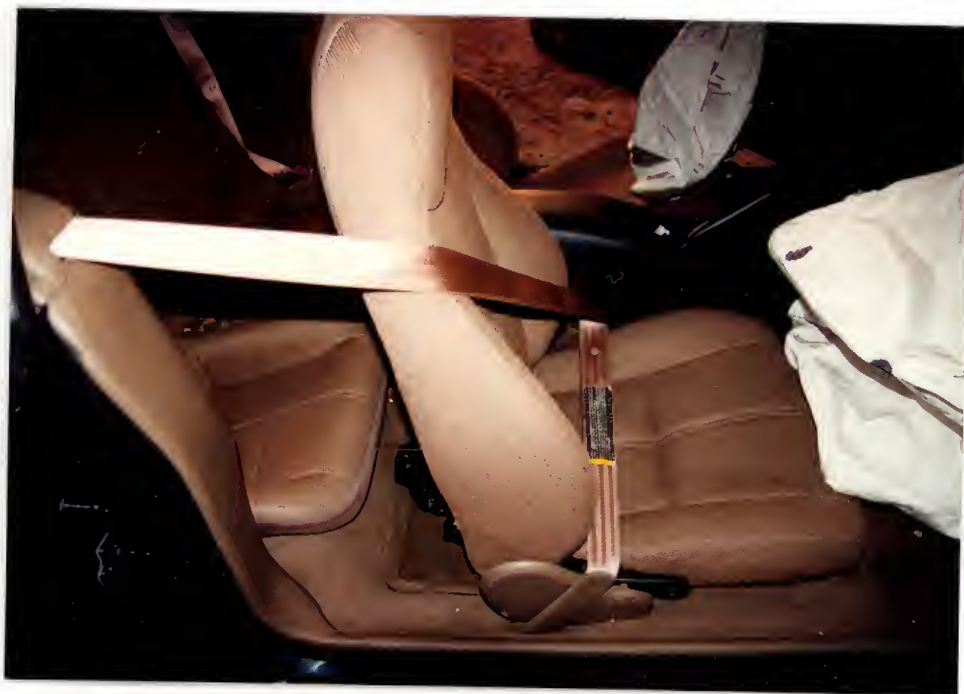
98. A closer view of the right front seat.

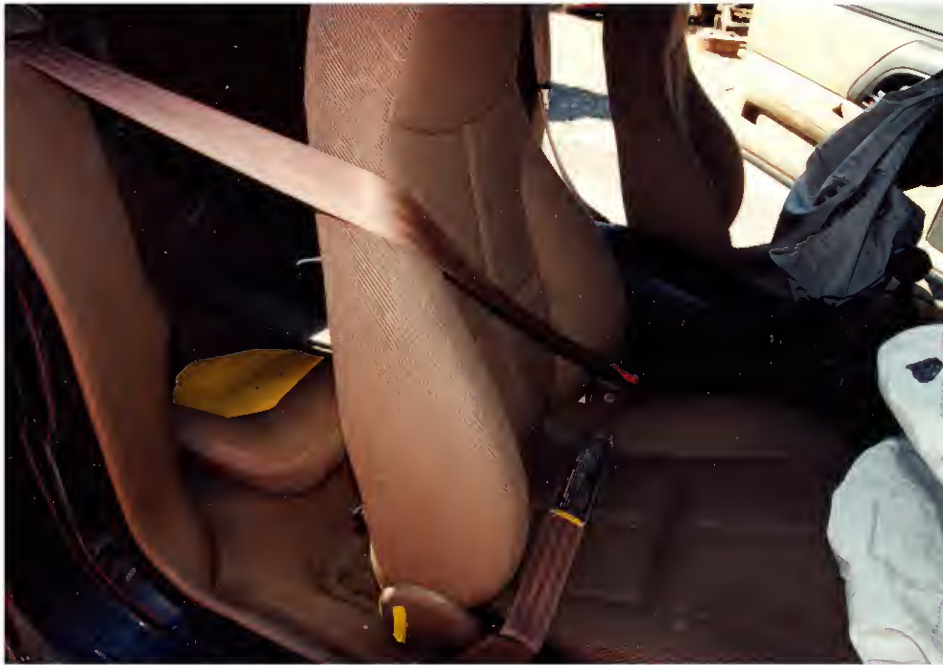
99. Rearward facing angular view of the right front seat.

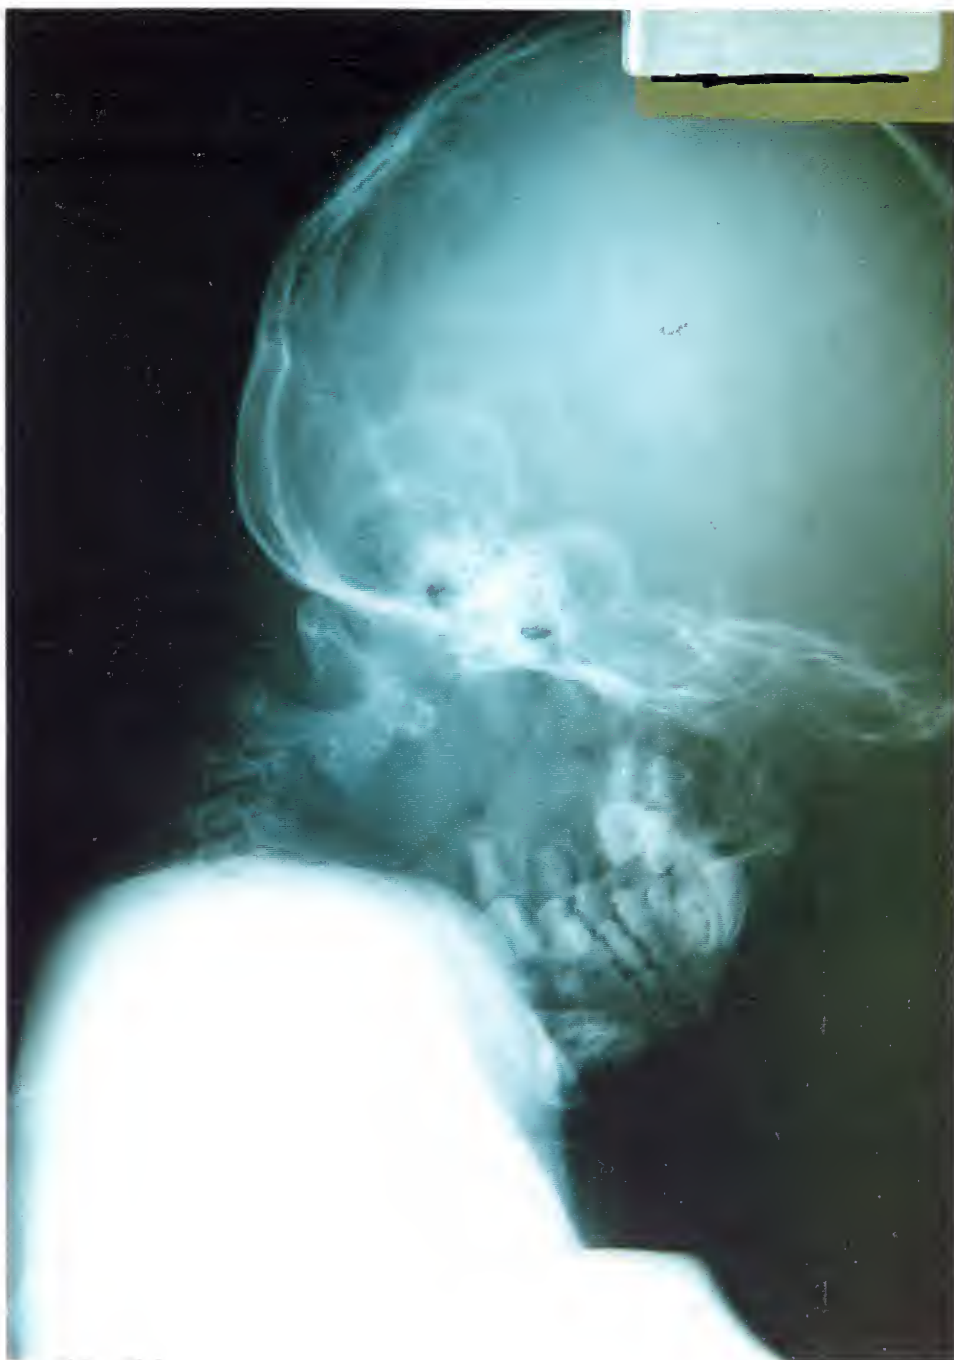
116. View of the neck in the flexion position.
